SIMPLE TECHNICAL MANUAL

YND 018 [**ECODESIGN**]

Monosplit / DC Inverter

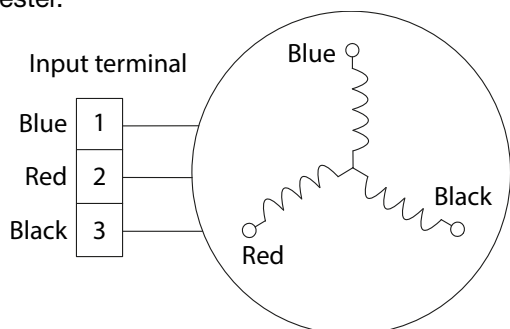
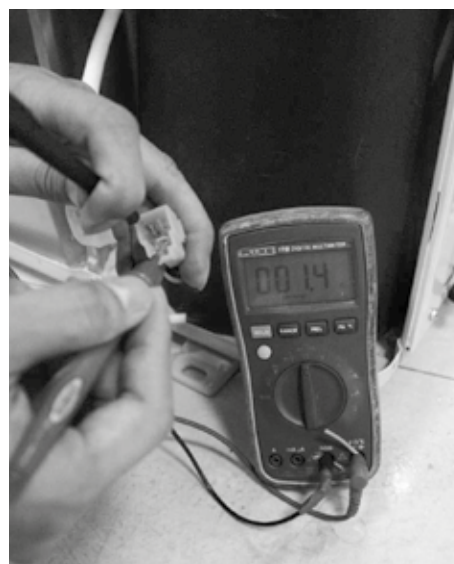
[COMPRESSOR CHECKING]

→ Measure the resistance value of each winding by using the tester.

Position	Resistance Value		
	ASN108D22UEZ	DA150S1C-20FZ	DA250S2C-30MT
Blue - Red			
Blue - Black	1,5 Ω (20 °C)	0,95 Ω (20 °C)	0,55 Ω (20 °C)
Red - Blue

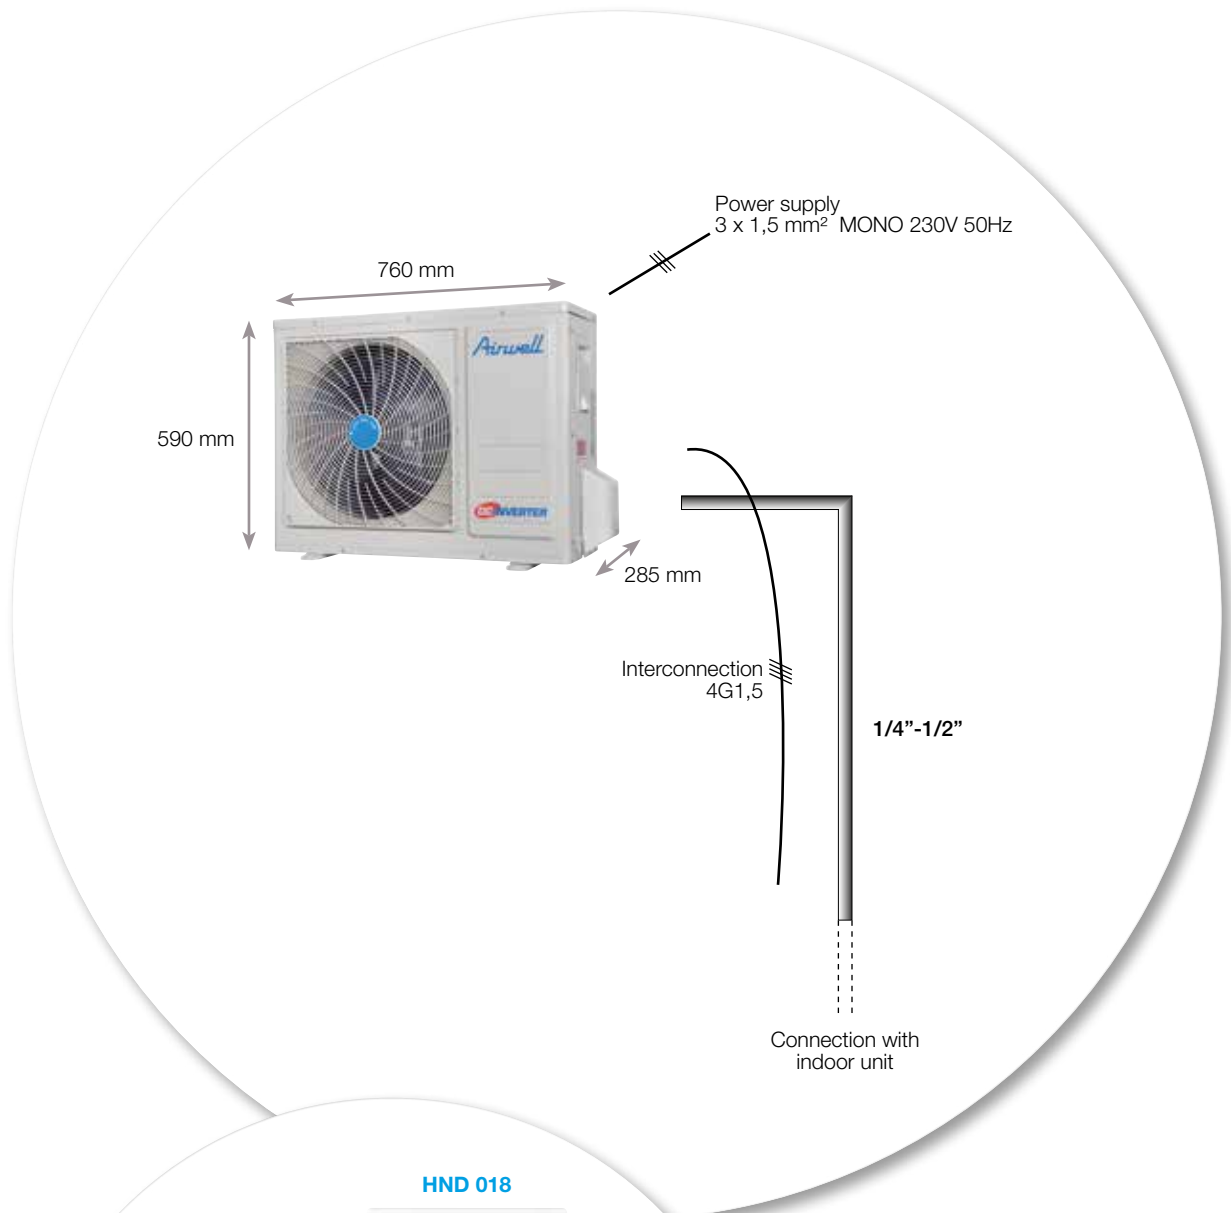
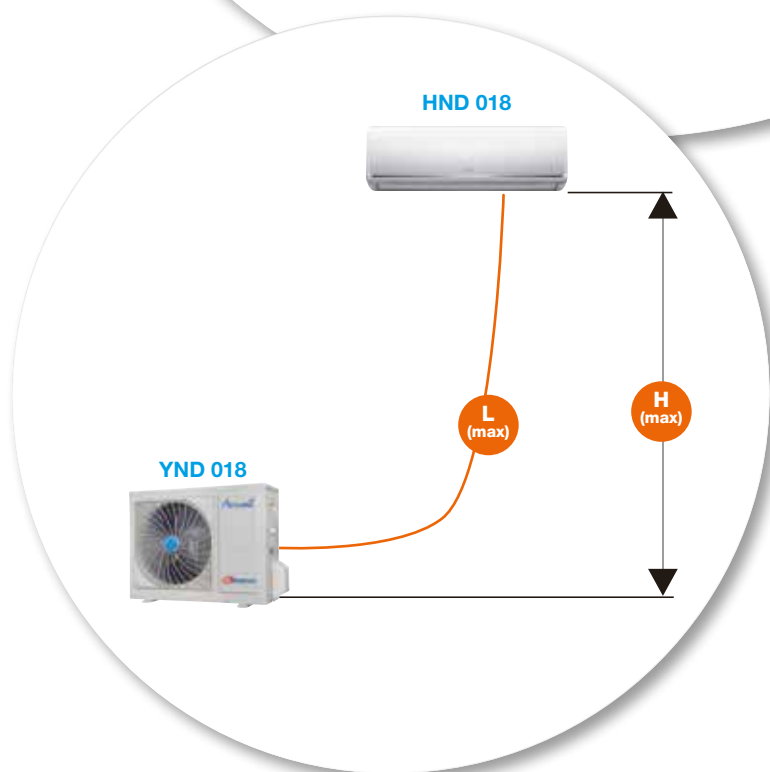
→ L(max) = 20 m

→ H(max) = 8 m

- Cable
- ▬ Pipe
- ≡ Number of wires
